Silicon Precipitate Nodule-Induced Failures of MOSFETs

M. Johnson and D. Pote
Motorola, Inc.
Northbrook, IL

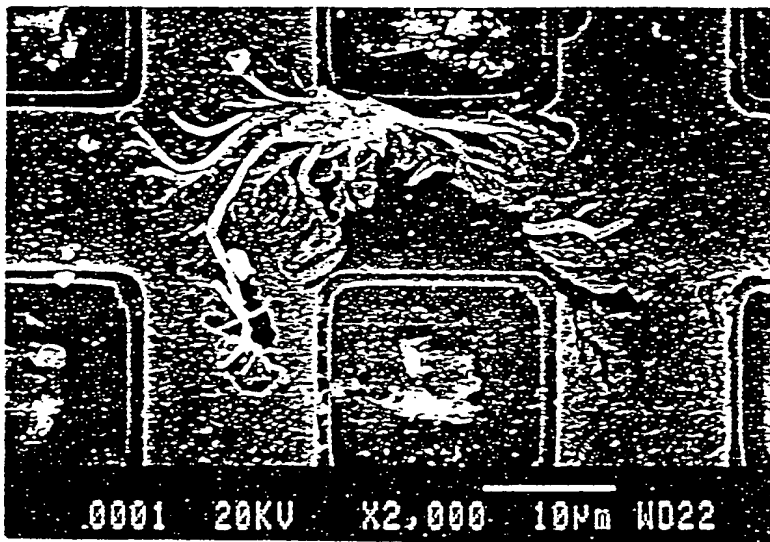
Figure 1: Unique pattern of fused polysilicon observed after removal of metallization and insulating oxide. (2000X)

Subsequent optical inspection identified an apparent electrical damage site under the wirebond. This damage was characterized by a central fused-site surrounded by multiple filaments (Figure 1). These filaments were dubbed "tentacles" or "roadkill" damage because of their appearance. SEM inspection of the same locations revealed surprisingly little

It is now believed that the filaments are the result of amplification of the damage at the original failure sites by the application of excess power during liquid crystal testing. A slightly higher level of power was necessary to counteract the obstructing heatsink effect of the relatively large wirebond. The heat generated at the damage site would initiate crystallization of the amorphous polysilicon depend-

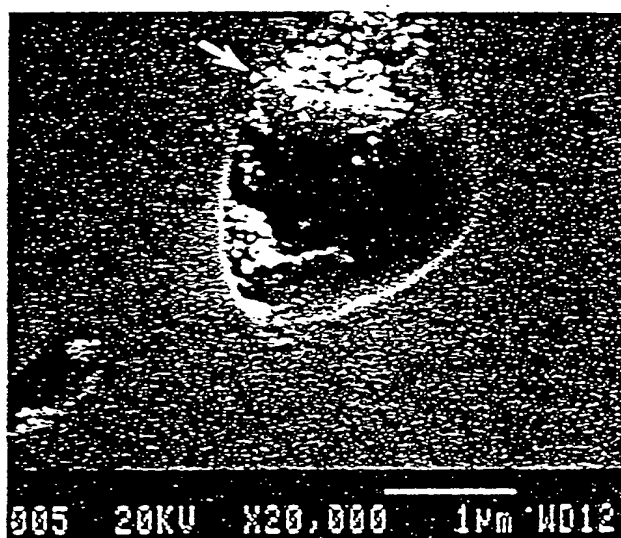
Figure 2: Small electrical damage site within chip.
(25000X)

Cross-sections of failures revealed that the filaments were confined to the polysilicon layer, except at the central nucleus. At the nucleus, melted silicon and aluminum were observed extending vertically through the dielectric layer. On several devices where the filamentation was minimal, there was limited evidence of melting at the nucleus site and a small section or chip of the dielectric was missing (figure 2).

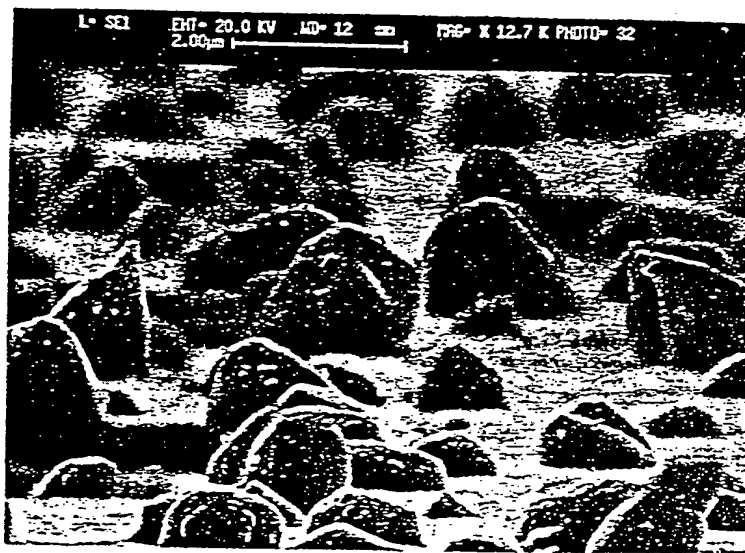
shape. Although they appear roughly circular under high power microscopy (400X), they are actually polyhedral and exhibit a wide range of aspect ratios (Figure 3). Typical height/width ratios range from 0.3 to 1.8.

Figure 3: Silicon precipitates (nodules) viewed from side exhibit variety of shapes and sizes. (12700X)

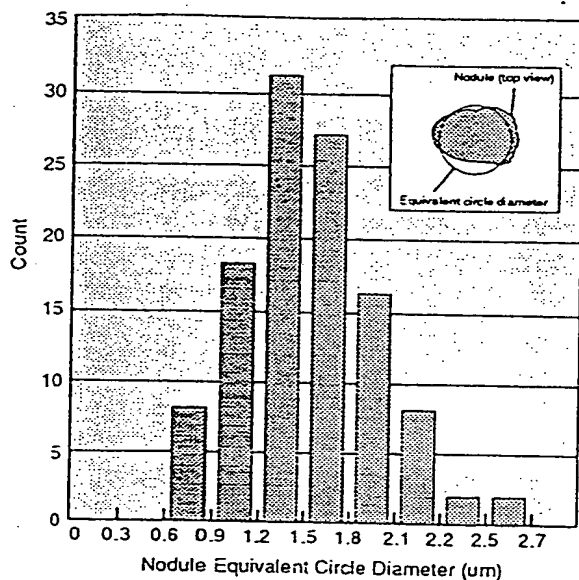
There were typically 50×10^3 to 100×10^3 nodules per square millimeter in the subject devices. In general, the nodule density -- the number of nodules per unit surface area -- was inversely proportionate to the average size of the nodules. That is, when the nodules were large, there tended to be few of them. Conversely, when the nodule count was high, they tended to be small. Figure 4 shows a typical histogram of nodule sizes produced by an image analysis

Figure 4: Example distribution of nodule sizes

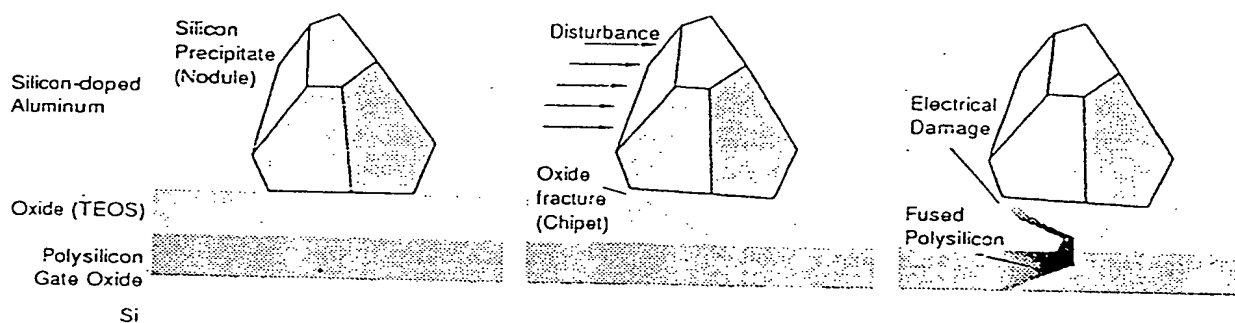
The adhered nodules could be removed quite easily; gentle brushing of a few fibers from a cotton swab was sufficient to disturb them. When these well-adhered nodules are displaced, they often take with them a portion of underlying oxide, forming a distinctive, football-shaped chip-out, or *chipet* (Figure 5). The depth of the resulting chipet was roughly equal to half the length of the chipet's minor axis, itself related to the area of contact between nodule and oxide.

In the MOSFET devices the lateral displacement of the nodules occurs during the wirebonding process. The cavity formed by the chipet is immediately filled with aluminum. These chipets, during

Figure 5: Movement of nodule results in fracture of underlying oxide.

electrical stress, appear to act as weak points in the insulating oxide. If the chiplet is sufficiently deep to fully compromise the thickness of the dielectric oxide, a linear resistive short between the source metallization and gate polysilicon results. However, if the root only partially compromises the dielectric, a leaky diode-like characteristic results.
